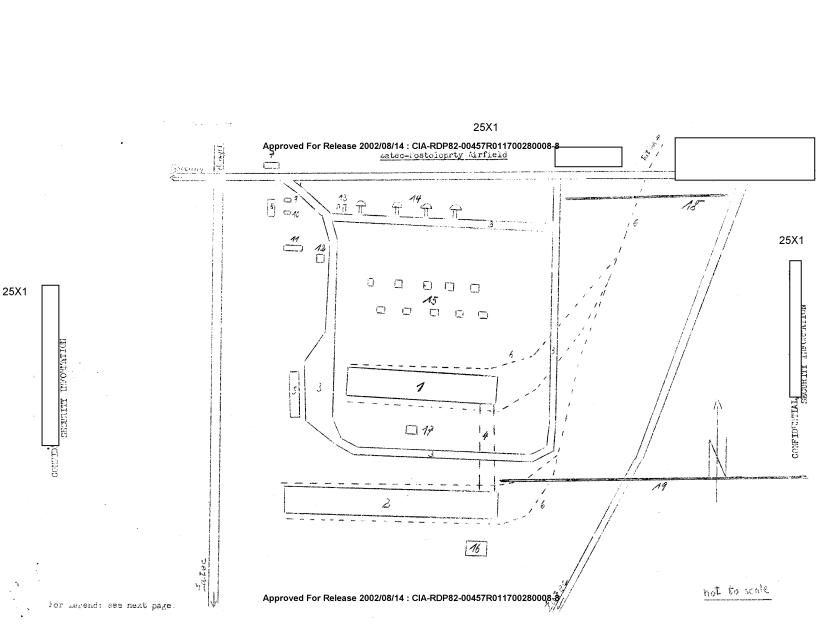
- 1. Short runway.
- 2. Long runway.
- 3. Concrete road.
- 4. Concrete road under construction.
- 5. Hangar.
- 6. Drainage canal.
- 7. Office of the Konstruktiva building enterprise.
- 8. Yess hall for military and civilian workers.
- 9. About 5 low wooden buildings, quarters for construction workers.
- 10. About 5 low wooden buildings, quartering facilities for a military labor detail.
- 11. Quarters for air force personnel.
- 12. Underground fuel tanks, filling station for vehicles.
- 13. Houses under construction.
- li. Underground installations with iron doors.
- 15. Houses under construction.
- 16. Quarters for guard personnel.
- 17. Main guardhouse with observation tower.
- 13. Spur track to the Postoloprty railroad station.
- 19. Temporary spur track.

**	Comment. For layout sketch of the field, see Annex. The four underground installations are believed to be storage facilities for amounition or fuel. Comment. The present report in conjunction with previous information furnishes a good picture of the status of the field. However, it is believed that the length of the two runways at the field was underestimated, while their width was exaggerated. The northern runway was	25X1
	mentioned already in a report dating from September 1918 and it is believed to have been in existence at the end of the war, but the other runway was not built before 1950 or 1951. The latter runway probably meets modern requirements. It is assumed that the northern runway is chiefly used for the parking and servicing of aircraft, as the soil of the field appears to be rather soft. The arrival, in September 1951, of air force soldiers indicates that the installation may be ready for occupation in 1952.
